Aros Waterfront Development

Engineering Services – Pier Restoration

INVITATION TO TENDER

REPORT ON STRUCTURAL INSPECTIONS

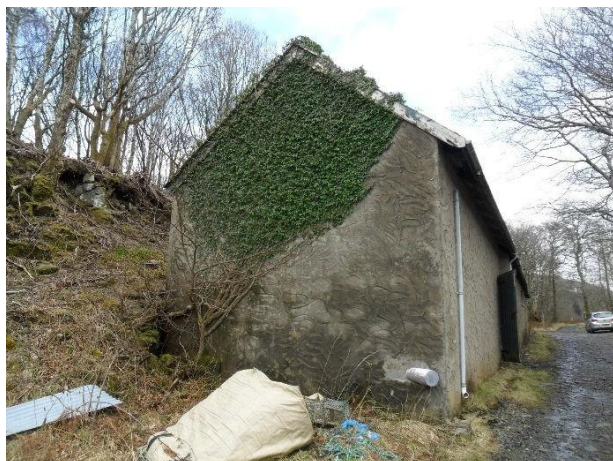
Vegetation to north gable

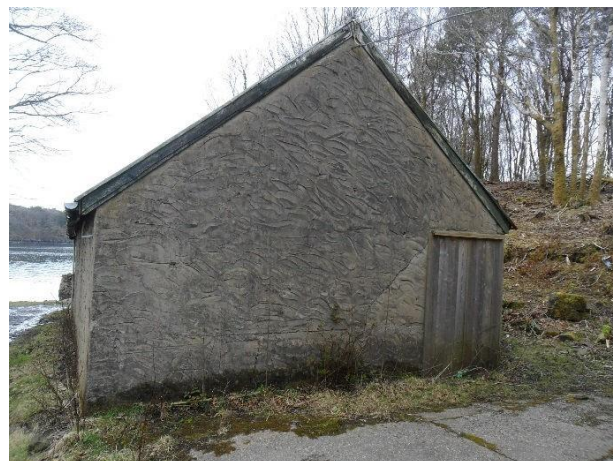
The west face and both gables of the boathouse are rendered externally with a cement render. There is some minor cracking to this render, and a diagonal crack at the door in the south gable. This latter appears to have been caused by impact damage.

South gable showing crack at door

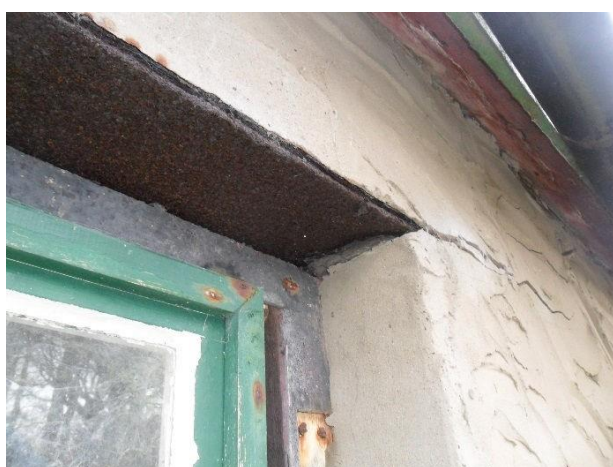
There is surface corrosion of the steel lintels at the windows with cracking of the render extending from these. The window frames are rotten and most of the paint is missing. The windows are all single glazed. The door on the west face is in fair condition. The door opening in the south gable has been boarded up.

Corrosion to lintel; cracking

All windows and doors require replacement, along with lintels where these have corroded or are rotten. It may be desirable to provide larger or additional window openings. New gutters and downpipes will be required along both side faces of the building, connected to a suitable outfall.

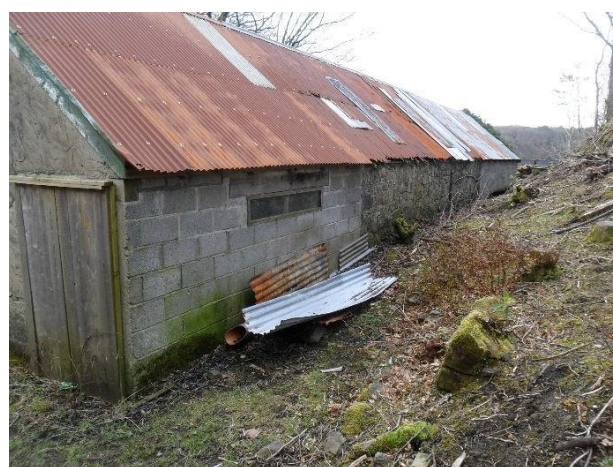
The east face has no external render and the stone and blockwork are exposed. All are generally in good condition, with well pointed joints, and with a vertical crack in the blockwork below the window in the south extension. The ground level along most of this face is well above the internal floor level, leading to damp penetration inside the building. There is some vegetation growth on the north gable, extending round the corner to the east side where the ground level is above the internal floor level.

The roof is all of corrugated iron which has corroded to a varying extent. The lower ends of the sheets on the east side have corroded to the extent that some of the sheeting is missing, allowing moisture penetration into the eaves and the wallplate level. The roof timber rafters all appear in fair condition, but the spacing of rafters, and lack of ties, suggests that the roof would not meet current design standards. The floor joists on the north extension are in fair condition, but the boarding shows signs of damp. The ceiling joists on the south extension are sagging.

Rear view showing ground level; roof corrosion

It is considered that the roof will require complete replacement. The timber rafters and trusses are inadequate for current design loadings, and there are areas of deterioration in them. The sheeting will in any case require to be replaced. This could be done with modern profiled metal sheeting, or to match the historic nature of the building it may be desirable to use natural slate. Insulation to current standards would be required. In order to replace the roof, it will be necessary to carry out some repair work to the tops of the walls to provide a suitable uniform seating.

The ground level around the building, particularly on the east side, is above the internal floor level. The ground should be excavated back to at least 150mm below floor level and a drainage path created around the building. A damp proof course may also be required. It is recommended that the east face be rendered to match the other faces of the building.

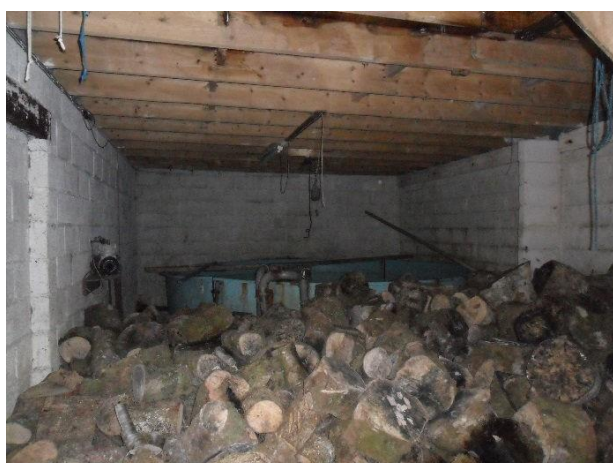
North extension block and upper floor joists

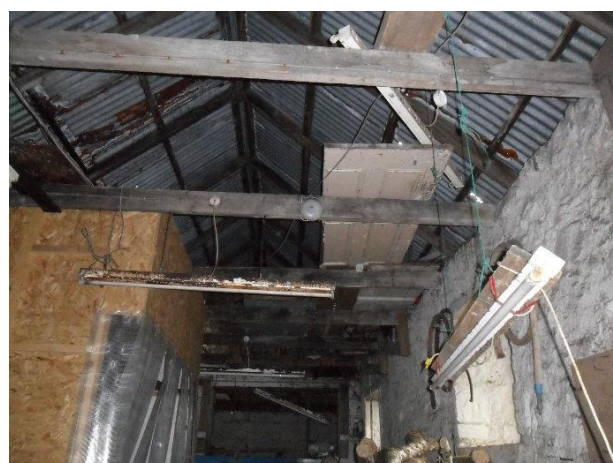
Middle section roof trusses

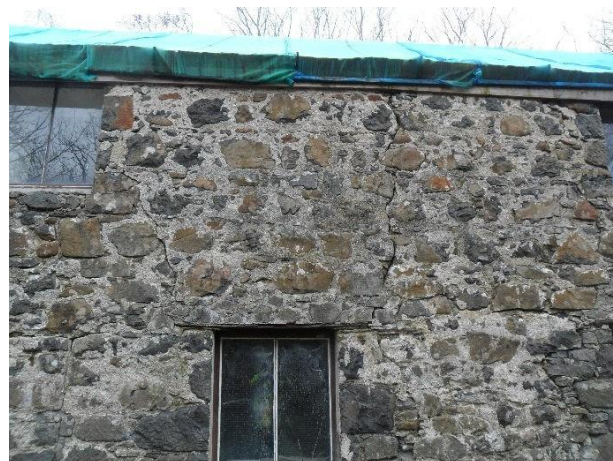
The random rubble stonework of the sawmill building is generally in good condition. There are a few vertical or diagonal cracks in the walls, generally close to openings for windows or doors. Many of the joints in the stonework are open.

Cracking to west wall near windows

The cracks in the walls, particularly on the west face, should be repointed with a suitable mortar to match that existing, and monitored for any signs of further movement. It is considered that the movement noted is historic and will not be ongoing.

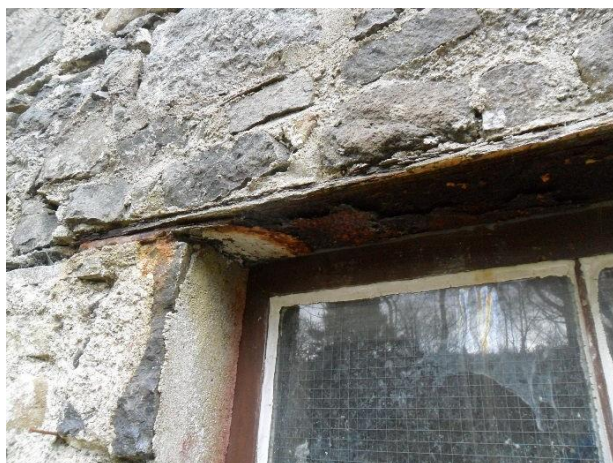
The lintels over the north gable door are all of precast concrete and are in good condition. All other lintels are of steel on the outer face and timber on the inner faces. There is extensive surface corrosion to most of the steel lintels. The timber lintels are mostly in fair condition, but there is some rot to the lintels on the south gable opening. The windows and doors (where present) are generally in poor condition with some rot, and flaking paint. Windows are all single glazed.

Corrosion to lintel; cracking to wall

Windows and doors should be replaced, or added on the south lower floor where there are no doors in the present openings. The steel lintels should all be replaced, along with those timber ones showing signs of deterioration. New gutters and

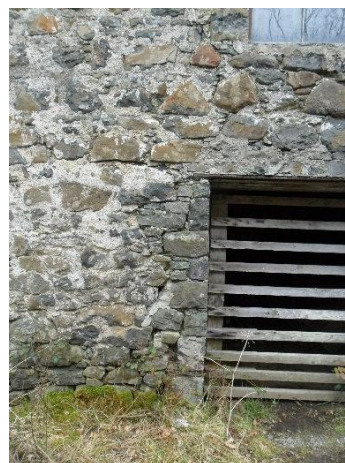
Vertical cracks adjacent to openings

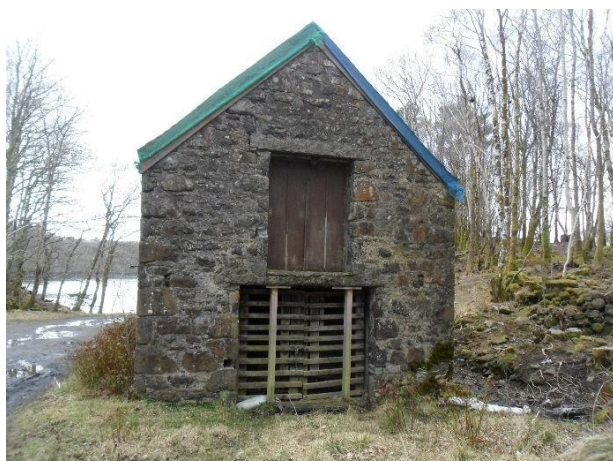
South gable: propped lintel; cracking upper lintel

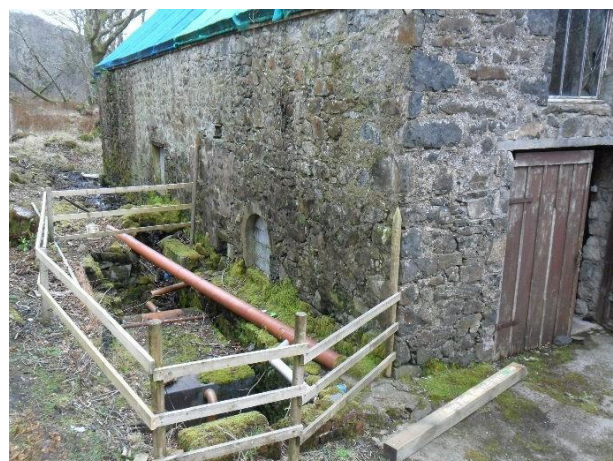
The east face stonework is generally in fair condition, well pointed and pinned, but particularly towards the south end where a stream flows towards the building there is some vegetation growth and damp. The pit to the north end of this face (where the mill wheel was formerly situated) is still present, and there is extensive moss growth both within the pit and on the adjacent wall.

East face showing vegetation and old pit

A drainage channel should be provided on the east face where the water currently runs against the wall. The moss growth should then be cleaned off. The outfall from the former mill wheel pit should be investigated, and cleaned out or replaced as necessary, particularly if it is intended to restore a wheel here for electricity generation.

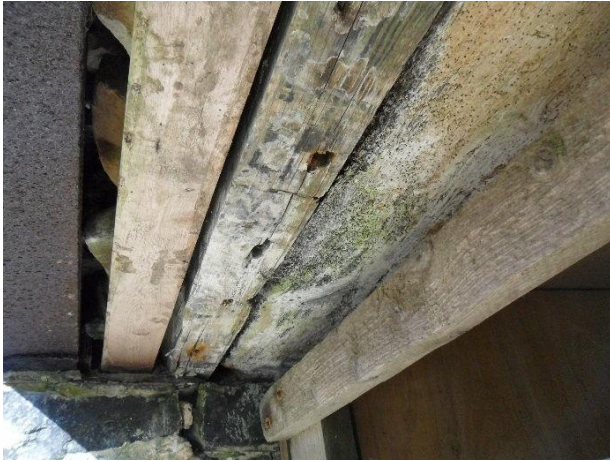
Inner lintels of south opening

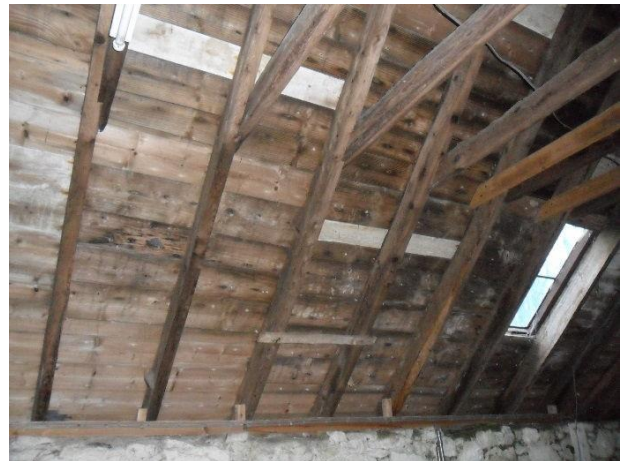
The roof line is good with no evidence of sag of the roof timbers. The slates are currently covered with mesh netting. Internally the roof timbers are generally in good condition, with some damp evident on some of the sarking boards. Some of the rafters are formed from sections of log and are not dressed square. There are occasional signs of rot to the lower ends of some of the rafters.

View of roof timbers

The roof trusses are generally considered adequate. Some rafter ends will require to be replaced where these are rotten. The sarking boards and slates will require a detailed inspection, and replacement as necessary.

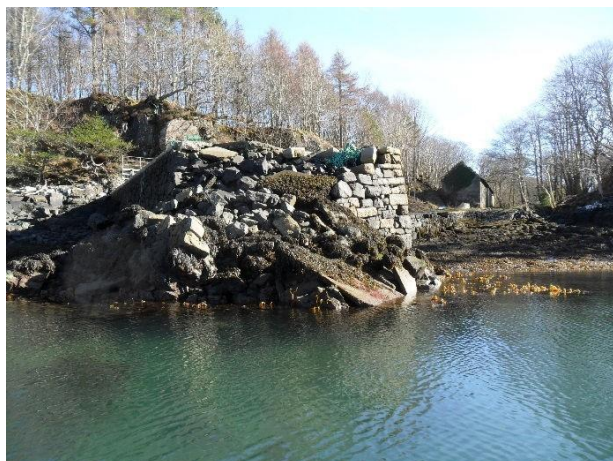
The old stone pier has collapsed towards its outer end, particularly on the north side which is exposed to the sea. Part of the south west corner is still intact to almost its original height. The rubble from the collapsed section is lying in and around the bed at the toe of the pier head. The foundation still appears intact.

End of pier showing collapse

If it is intended to use the pier, the outer end should be rebuilt to match the remaining part. It is recommended that in order to reduce its liability to future erosion, it is formed from a stone masonry facing with a mass concrete core, using the masonry as formwork. The existing broken concrete slab should be removed and a new concrete slab incorporating mesh reinforcement laid on a suitably prepared base. Cope stones should be replaced and bedded where these have been displaced.

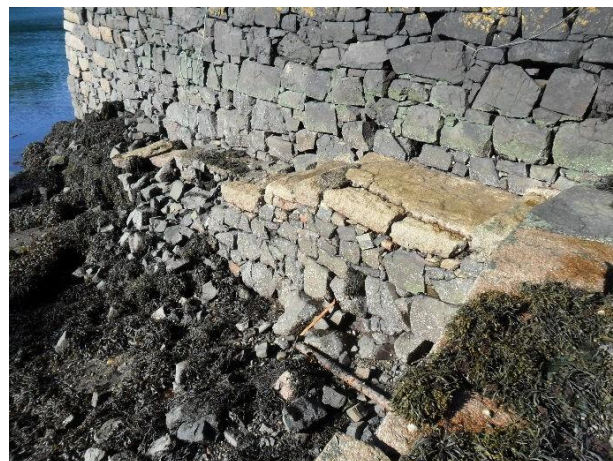
Collapsed end of steps

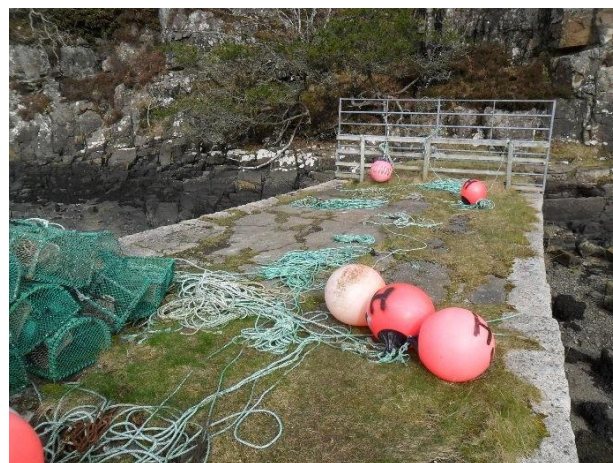
The concrete surface is in poor condition, with extensive cracking and large areas of grass growth. The pier is filled with random rubble, which has moved at the end adjacent to the collapsed areas, and there is some settlement in other areas. A metal fence currently restricts access to most of the pier.

Pier surface

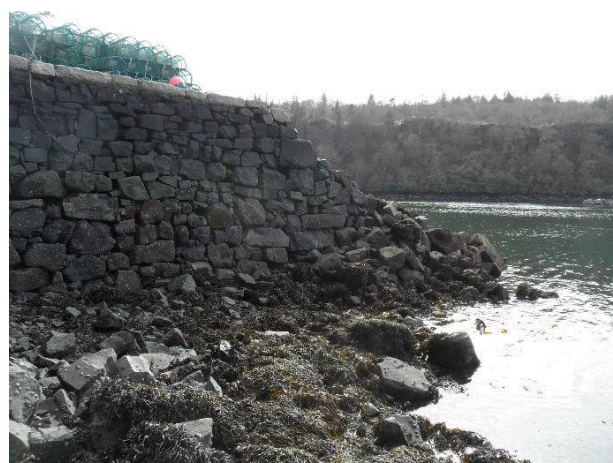
End of pier north face showing collapse

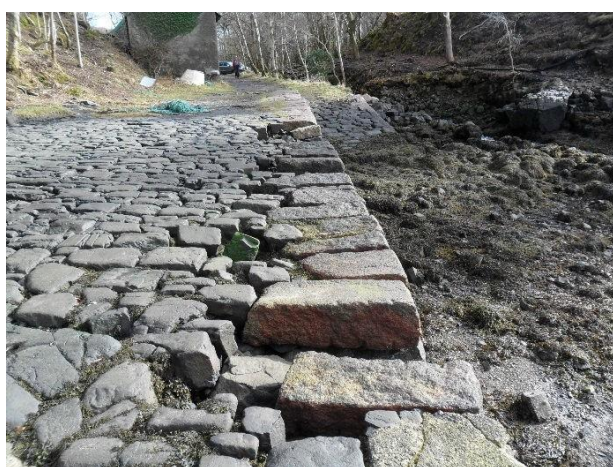
Displaced coping stones to wall

Cope stones should be replaced to the loading quay wall. Voids in the wall face should be filled with suitable stone and packed with pinnings and/or mortar to keep them in place.

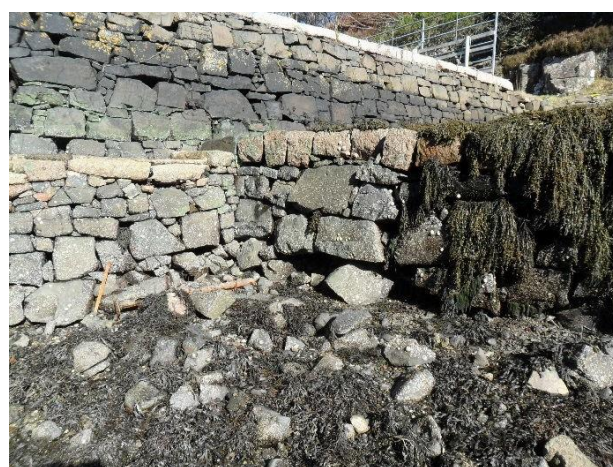
Voids under wall by steps

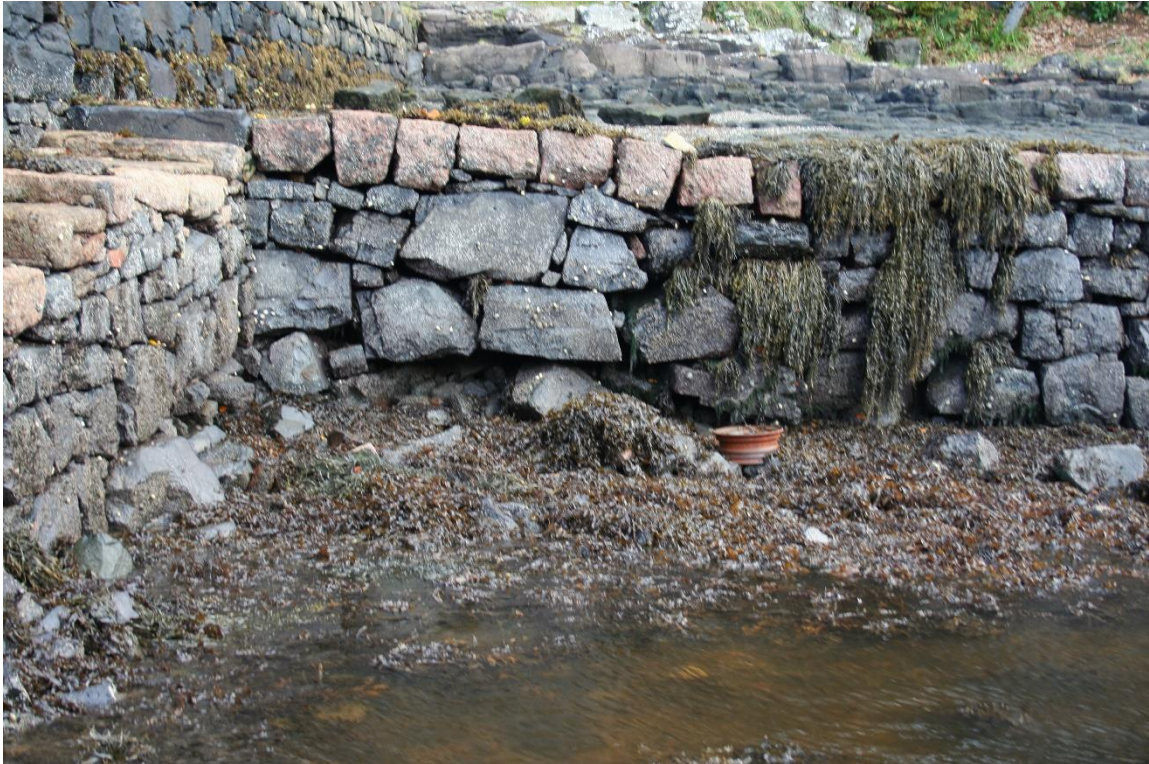
Gaps in the edge of the slip way present a hazard to members of the public walking along the space.

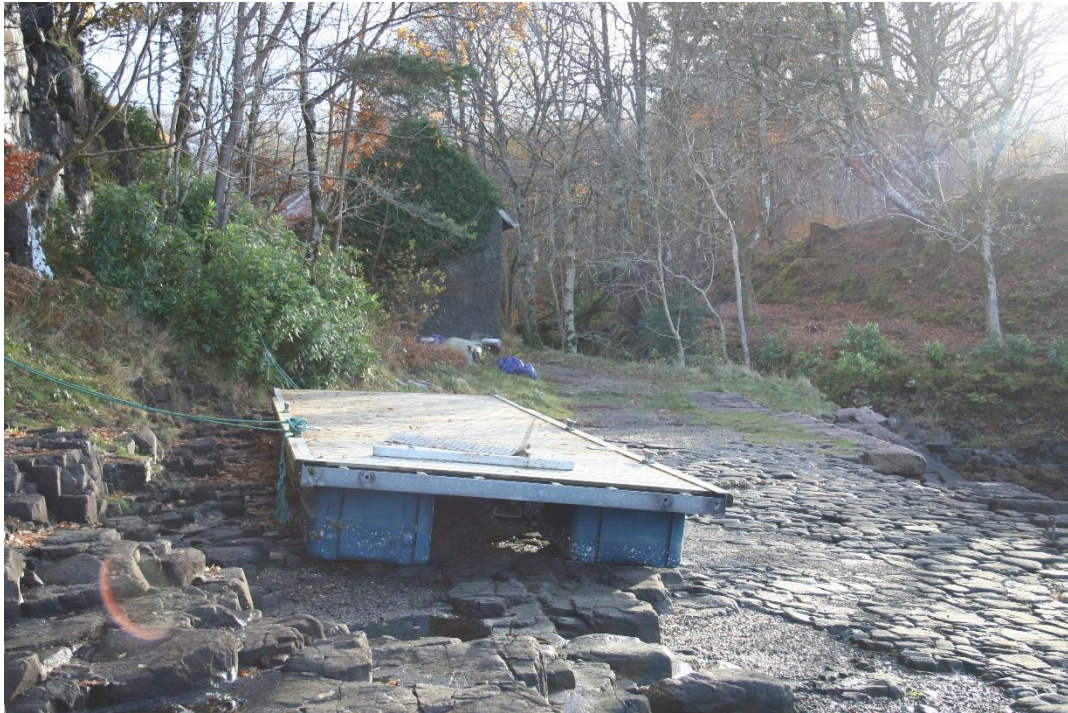
A section of pontoon owned by Tobermory Harbour Association is being stored on the slip. The slip is constructed of large, uneven, slippery boulders and filled with gravel.
